Subject: Annual Inspection Report
Roy Wilcox Airport

ANNUAL INSPECTION REPORT

JUNE 10, 2010

ROY WILCOX AIRPORT
CHATOM, ALABAMA

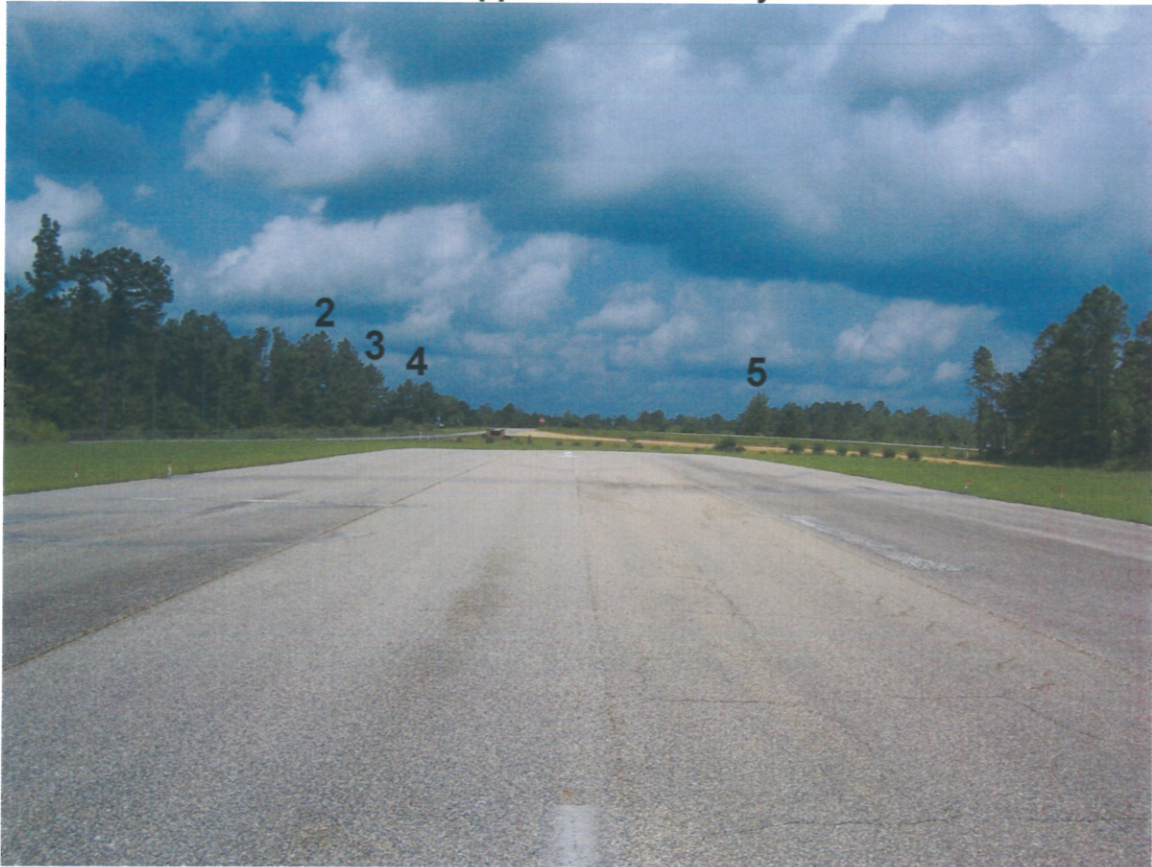
PHOTO 1 –Approach to Runway 12

- ➔ Runway 12 – The required 20:1 slope is violated by trees and a highway. The slope is reduced to 6:1.
- ➔ Runway 12 – The required 20:1 slope within the displaced Approach/Departure Path is violated by trees. The slope is reduced to 9:1.

Line of trees containing targets 2 through 5 violate the required 20:1 slope from the displaced threshold.

- Remove all obstructions to the 20:1 slope within the displaced Approach/Departure Path.

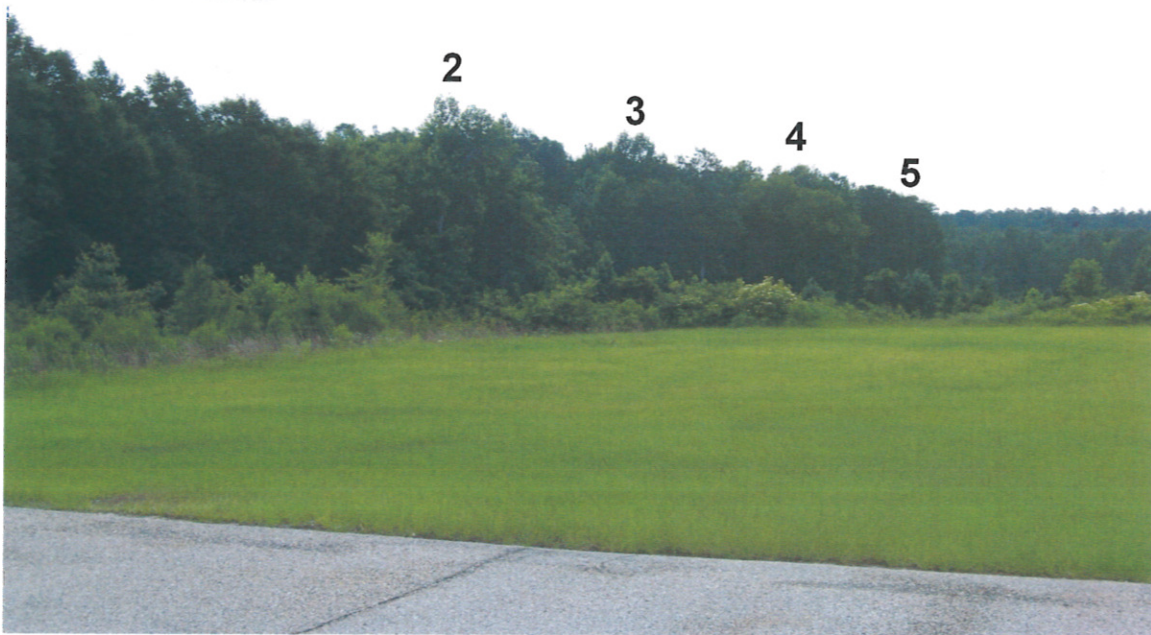
PHOTO 2 – Northwest edge of Approach/Departure Path of Runway 30

- A line of trees crosses the northwest edge of the Approach/Departure Path at approximately 890 feet from the runway end; reducing the slope to 12:1.
- See PHOTO 2 and Appendix 3 for location information.

The line of trees between targets 4 and 5 cross the edge of the Approach/Departure path. Target 3 is outside of the Approach/Departure Path and target 4 is located inside of the Approach/Departure Path. Target 5 is at maximum allowable height for a 20:1 slope.

- ➔ Remove all obstructions to the 20:1 slope within the Approach/Departure Path.

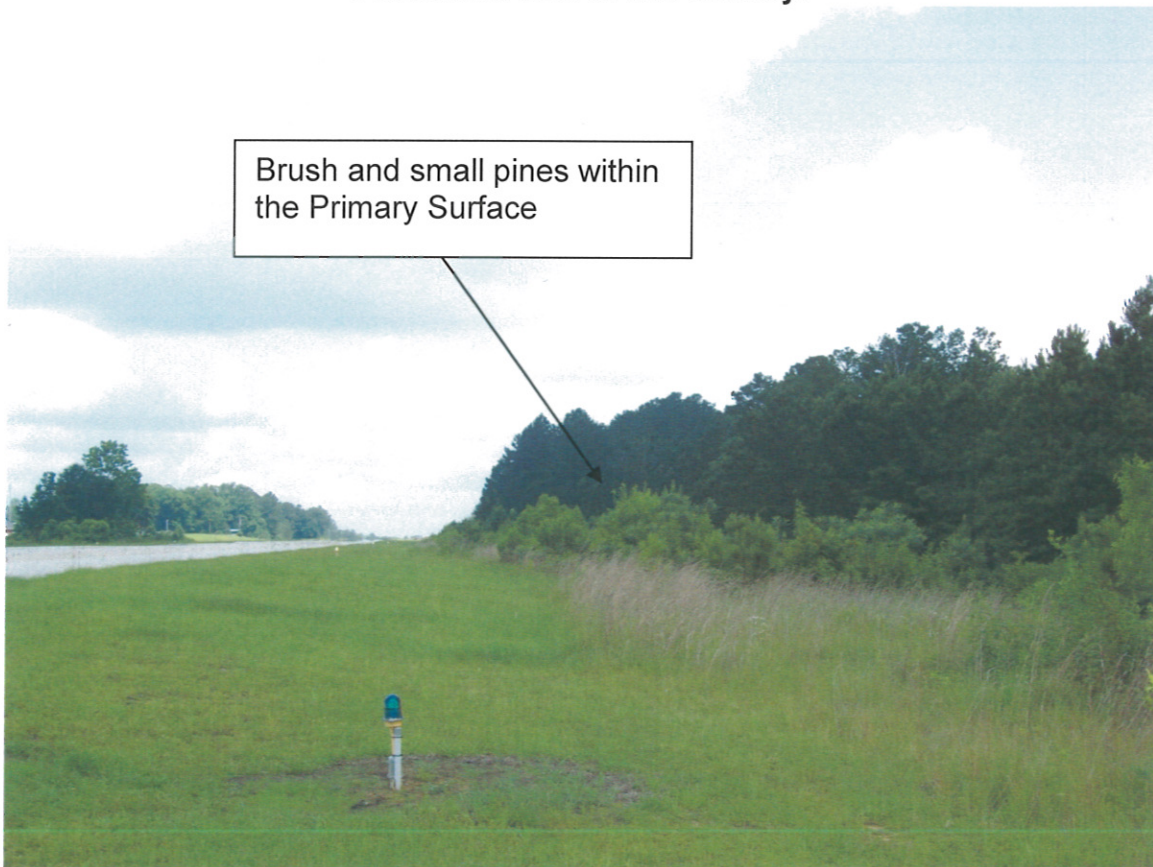
PHOTO 3 – Small trees and brush violating the Primary Surface along the southwest side of the runway.

- The primary surface was inspected and vegetation was found growing within the primary surface on both the east and west side of the runway with significant erosion on the west side of the runway in the same area.

The brush and small trees shown are within 87 feet of the runway centerline.

- The Primary Surface should be in mowable condition with all vegetation removed from within 125 feet each side of the runway centerline.

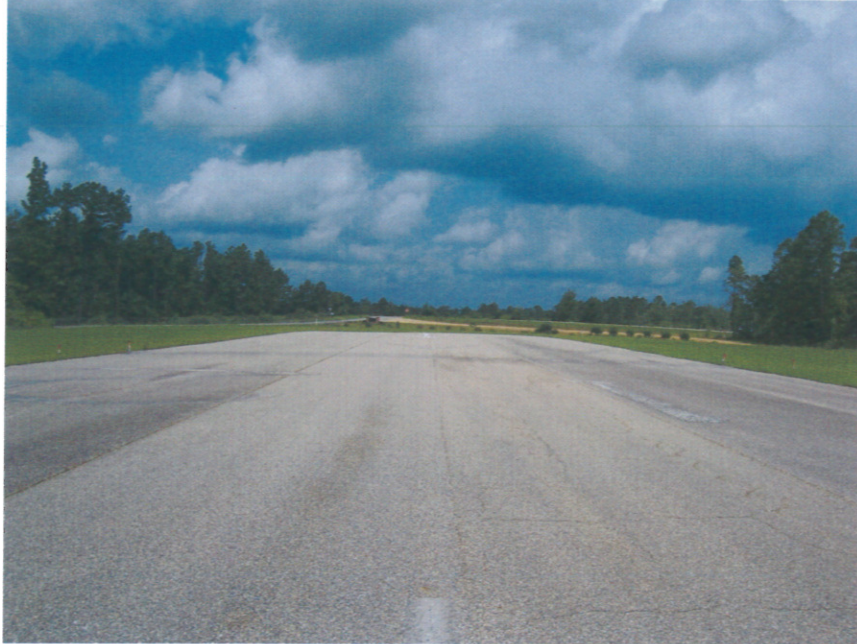
PHOTO 4 – Runway identifier markings of Runway 12

- The runway markings are in *poor* condition. Also, the size and shape of the runway identifier markings are not the standard recommended by the Federal Aviation Administration in FAA AC150/5340-1J "Standards for Airport Markings" as adopted by the Alabama Department of Transportation for the marking requirements of Public Use airports.

Note that the displacement markings are not legible.

- The runway markings should be remarked in accordance with FAA AC150/5340-1J "Standards for Airport Markings". The remarking of the runway could be included in a pavement maintenance project as described in **Section 7** (Runway, Taxiway and Apron Conditions) of this report.

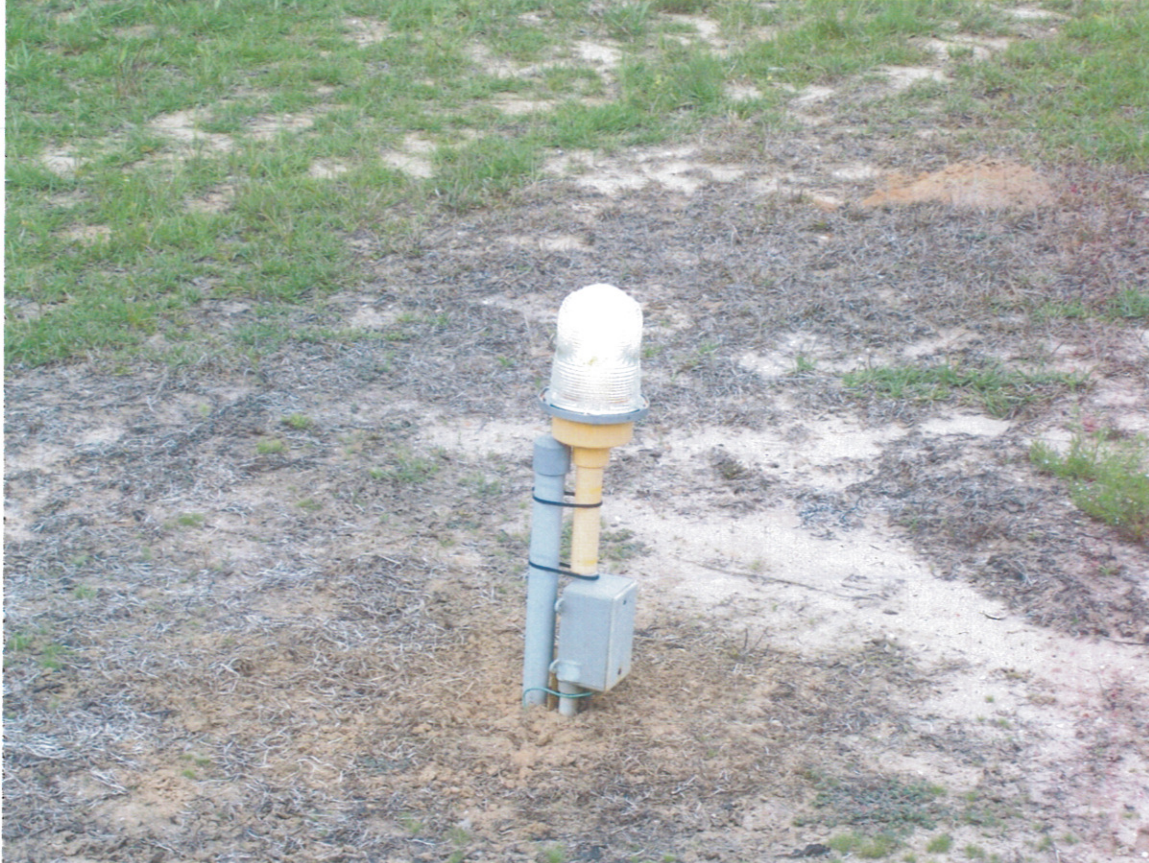
PHOTO 6 – Typical runway light fixture

- The airport lighting system was inspected and was operating at the time of the inspection.
- The runway and taxiway lighting have been upgraded recently and are now on frangible fittings.

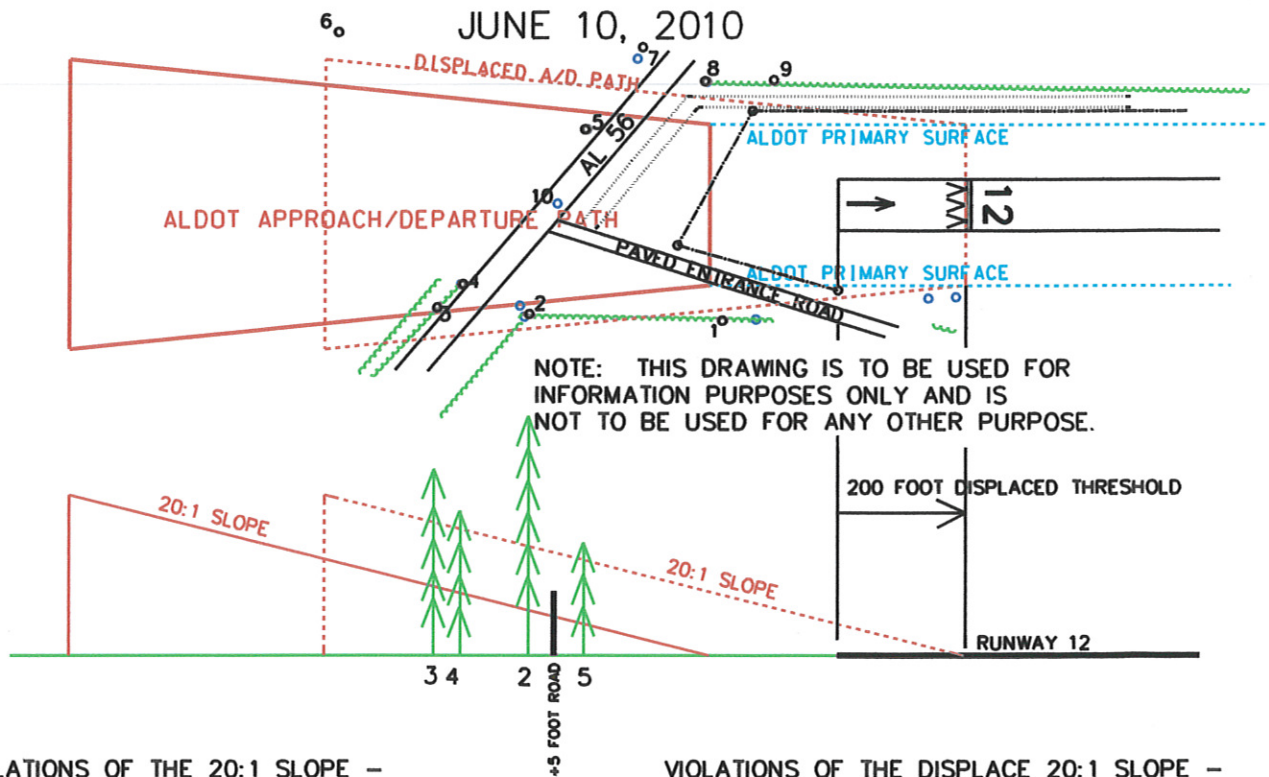
ROY WILCOX AIRPORT CHATOM, ALABAMA REQUIREMENTS FOR STATE AIRPORT LICENSE

VIOLATIONS OF THE 20:1 SLOPE -

2. +74 FOOT TREE
681 FEET FROM RUNWAY END
170 FEET FROM CENTERLINE
6:1 SLOPE
3. +58 FOOT TREE
825 FEET FROM RUNWAY END
160 FEET FROM CENTERLINE
10:1 SLOPE
4. +45 FOOT TREE
785 FEET FROM RUNWAY END
123 FEET FROM CENTERLINE
13:1 SLOPE
5. +35 FOOT TREE
595 FEET FROM RUNWAY END
117 FEET FROM CENTERLINE
11:1 SLOPE
10. +5 FOOT ROAD (+20 FOOT PER FAR PART 77)
438 FEET FROM RUNWAY END
PERPENDICULAR TO RUNWAY END
11:1 SLOPE

VIOLATIONS OF THE DISPLACE 20:1 SLOPE -

2. +74 FOOT TREE
681 FEET FROM RUNWAY END
170 FEET FROM CENTERLINE
9:1 SLOPE
3. +58 FOOT TREE
825 FEET FROM RUNWAY END
160 FEET FROM CENTERLINE
14:1 SLOPE
4. +45 FOOT TREE
785 FEET FROM RUNWAY END
123 FEET FROM CENTERLINE
17:1 SLOPE
5. +35 FOOT TREE
595 FEET FROM RUNWAY END
117 FEET FROM CENTERLINE
17:1 SLOPE

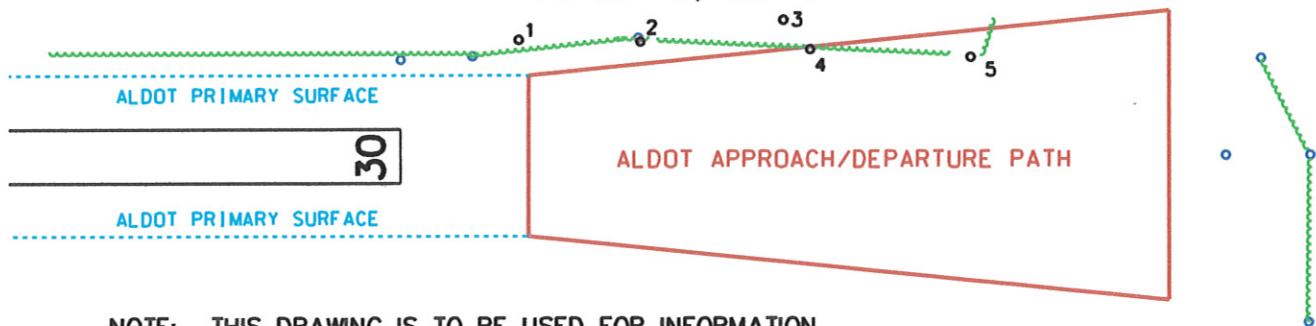
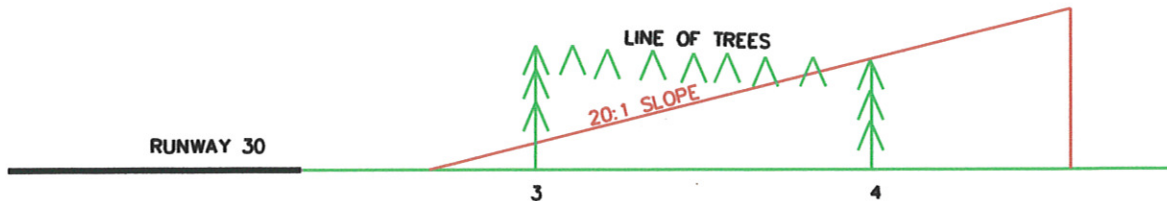
ROY WILCOX AIRPORT
CHATOM, ALABAMA
REQUIREMENTS FOR STATE AIRPORT LICENSE

VIOLATIONS OF THE 20:1 SLOPE -

4. + 41 FOOT LINE OF TREES ENDING AT TARGET #5
CROSSING THE APPROACH/DEPARTURE PATH APPROXIMATELY 890 FEET FROM RUNWAY END
152 FEET FROM CENTERLINE
REDUCING SLOPE TO 12:1
